Manhole Inspection Summary

Manhole # S31I__008MH

Insp Date: **10/29/08 3:03 PM**

Location Address: **32 s eutaw st**

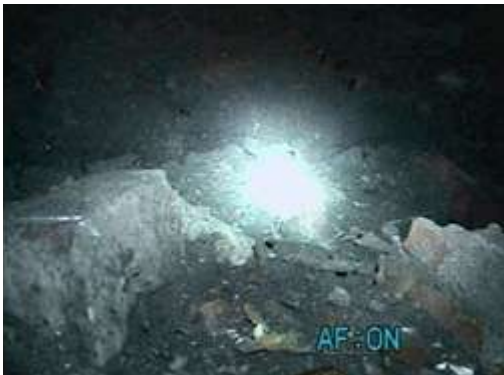
Defect 2

Condition: ☐ Sound ☐ Cracked ☐ Root Intrusion ☐ Deteriorated ☐ Leaks ☒ **Debris**

bench debris

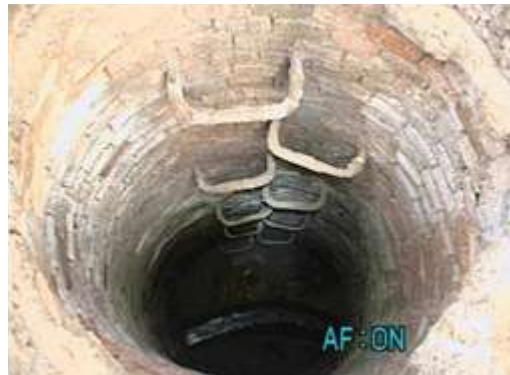
Defect 1

Steps Count: **9** Missing: **0** ☒ **Corroded**

corr steps

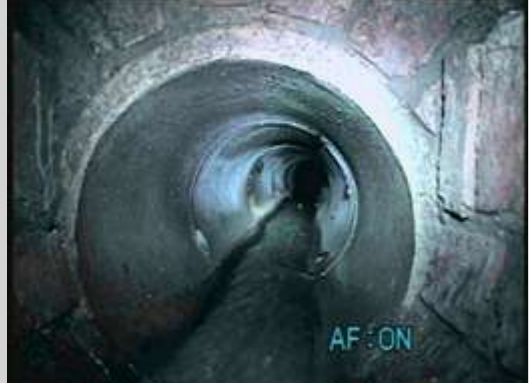
12 O'Clock Outflow

10 in. Circular Gravity Sewer
Pipe Out @ 12 O'Clock

Pipe Material: **Clay** ☐ Pipe Lined

Invert Depth: **16.46** (ft.) Flow Characteristics: **Fast**

Deposits: ☒ None ☐ Mud ☐ Sludge ☐ Debris ☐ Grease

Infiltration: **None** Pipe Seal Cond: **Unknown**

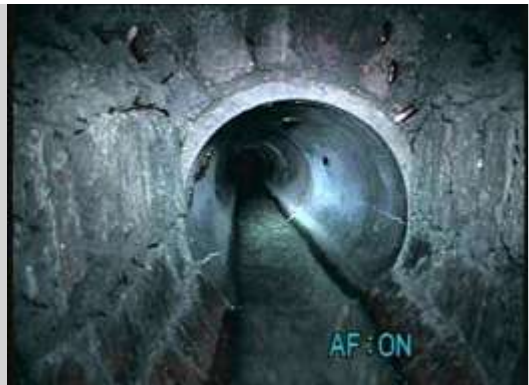
5 O'Clock Inflow

10 in. Circular Gravity Sewer
Pipe In @ 5 O'Clock

Pipe Material: **Clay** ☐ Pipe Lined

Invert Depth: **16.16** (ft.) Flow Characteristics: **Fast**

Deposits: ☒ None ☐ Mud ☐ Sludge ☐ Debris ☐ Grease

Infiltration: **None** Pipe Seal Cond: **Unknown**
